INTERSTATE COMMERCE COMMISSION

REPORT OF THE DIRECTOR
BUREAU OF SAFETY

ACCIDENT ON THE
SOUTHERN PACIFIC RAILROAD

INVESTIGATION NO 2375

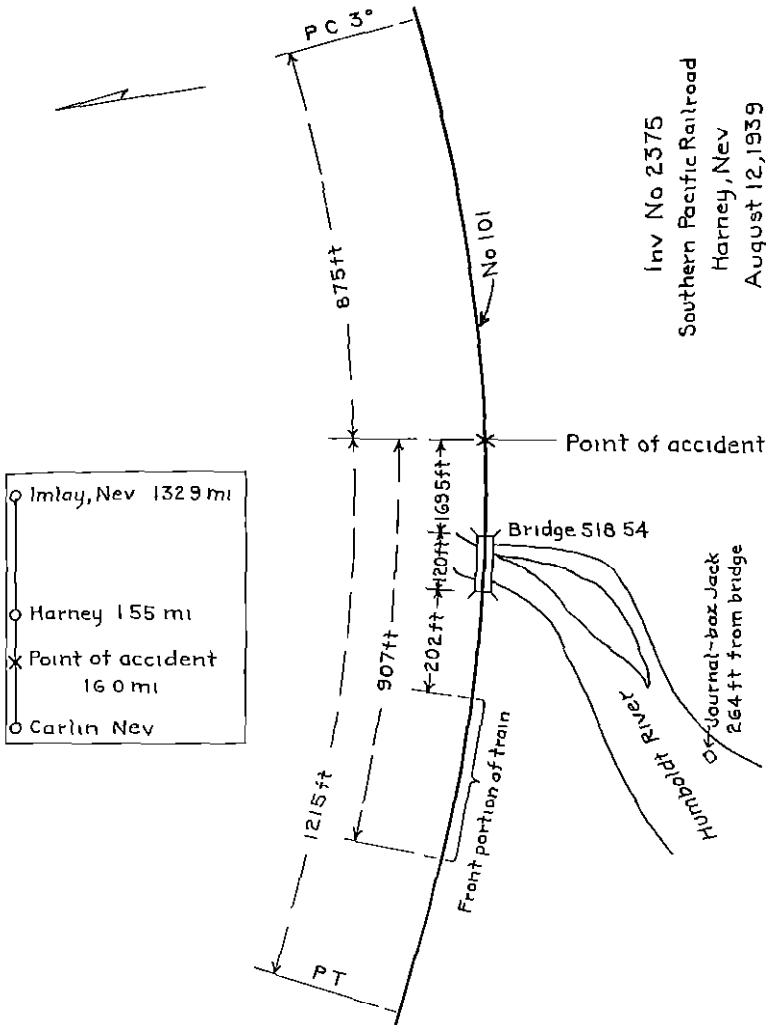
FIGURE 1—Track lay out in vicinity of point of accident

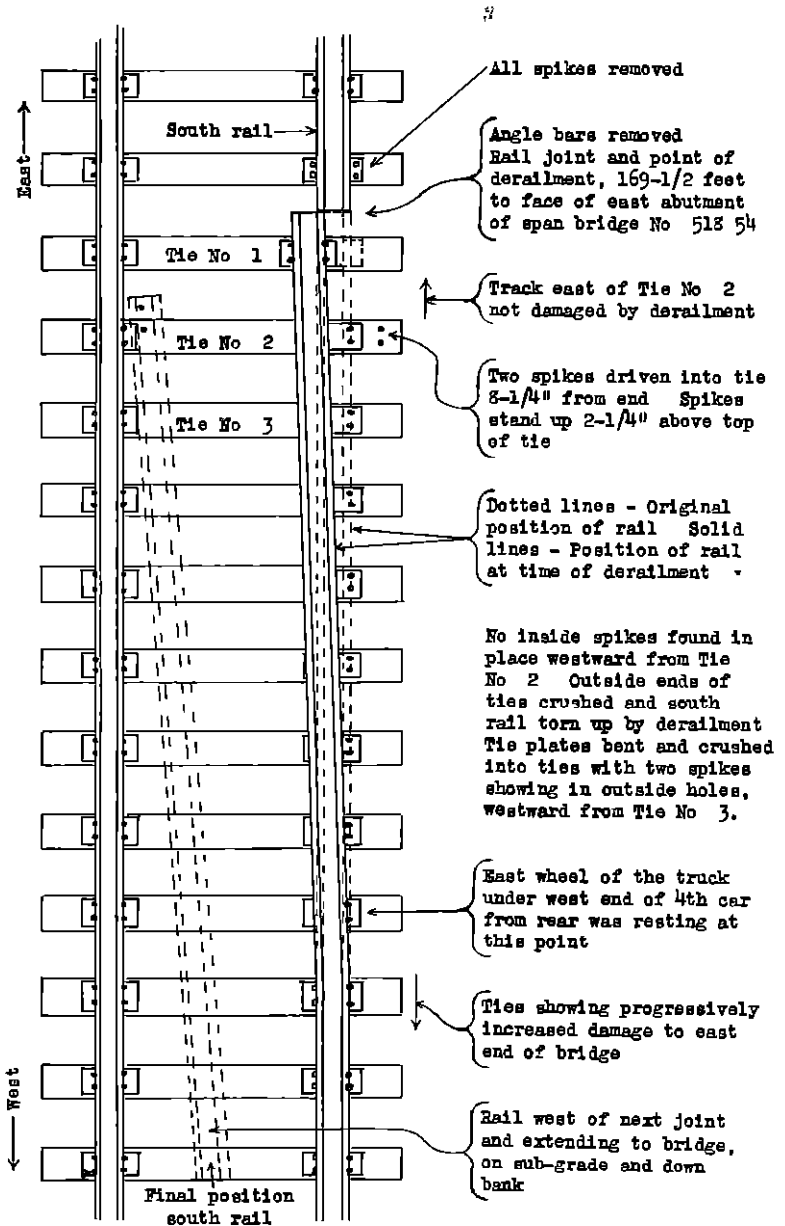
FIGURE 2 —Sketch showing normal mislaid and final positions of rail involved

and secured $4\frac{5}{8}$ inches inward from its normal position. All inside spikes were drawn from the following nine ties. Two spikes were driven close to each other and equidistant from the normal position of the rail and $8\frac{1}{4}$ inches from the south end of the second tie west of the joint in question, hereinafter referred to as tie No. 2, the heads were turned outward and protruded a distance of $2\frac{1}{4}$ inches above the top of the tie. There were four blocks of wood, each of which was about 2 inches by 3 inches by 6 inches, lying near ties Nos. 1 and 2. The rail immediately west of the joint in question was found lying on its side with its base toward the north and its receiving end $1\frac{5}{8}$ inches from the north rail and pointing diagonally in a southwesterly direction across the track. The next rail westward on the left side was along the edge of the ballast and down the embankment to the south. These rails evidently had been moved by some force striking at an angle, as evidenced by marks on the receiving end of the first misplaced rail. The north rails were undamaged and undisturbed. Starting at the third tie west of the joint in question the south ends of all ties were crushed and damaged by wheels, the damage increasing progressively westward. At the time of observation the fourteenth unit was standing with its west end 20 feet west of the joint involved.

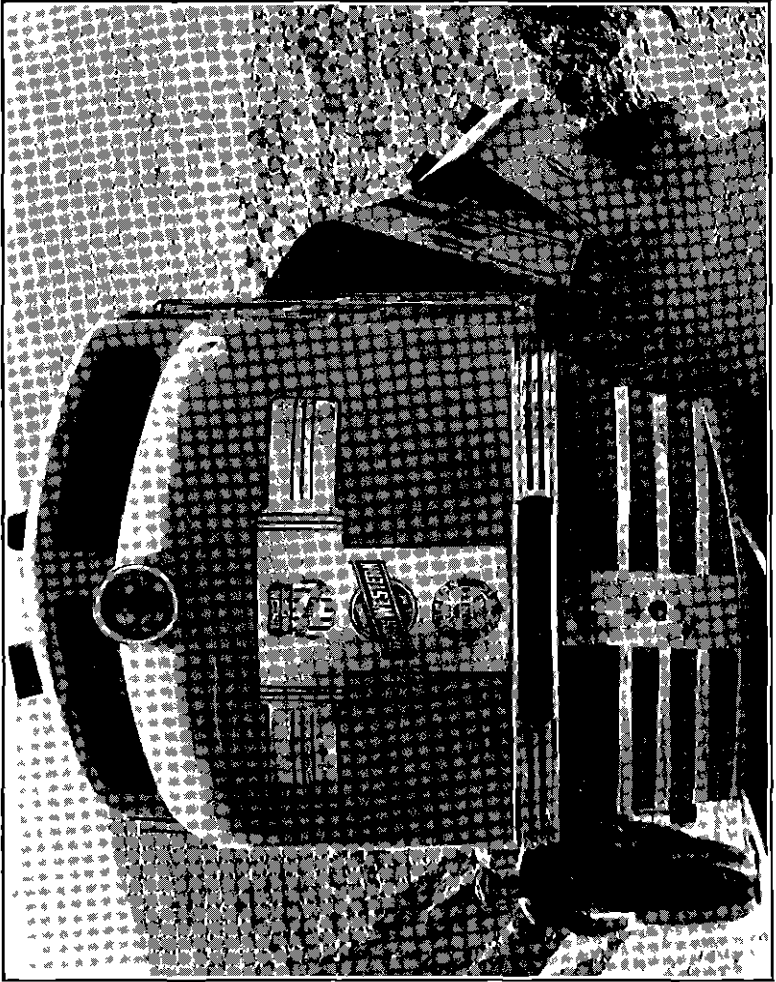
FIGURE 7.—View of the three power units, showing detailed condition of all units

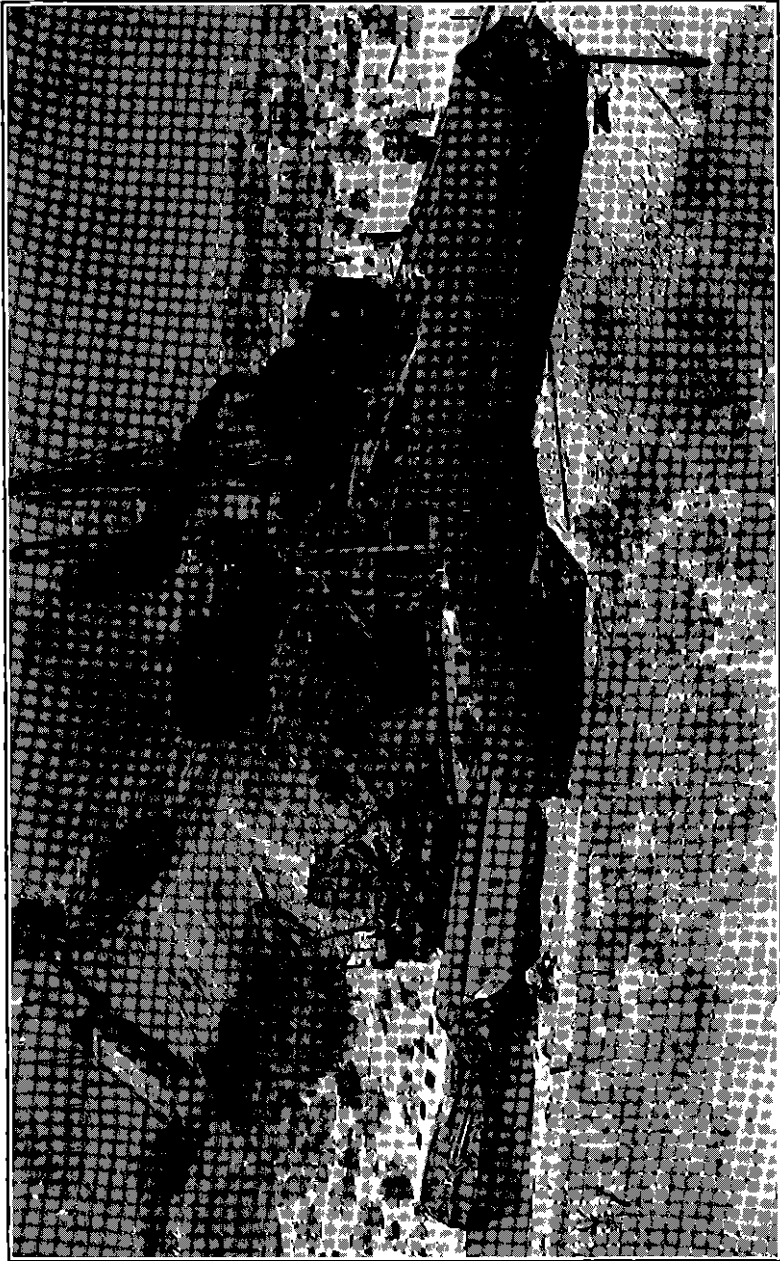
FIGURE 4—View of third to twelfth units inclusive

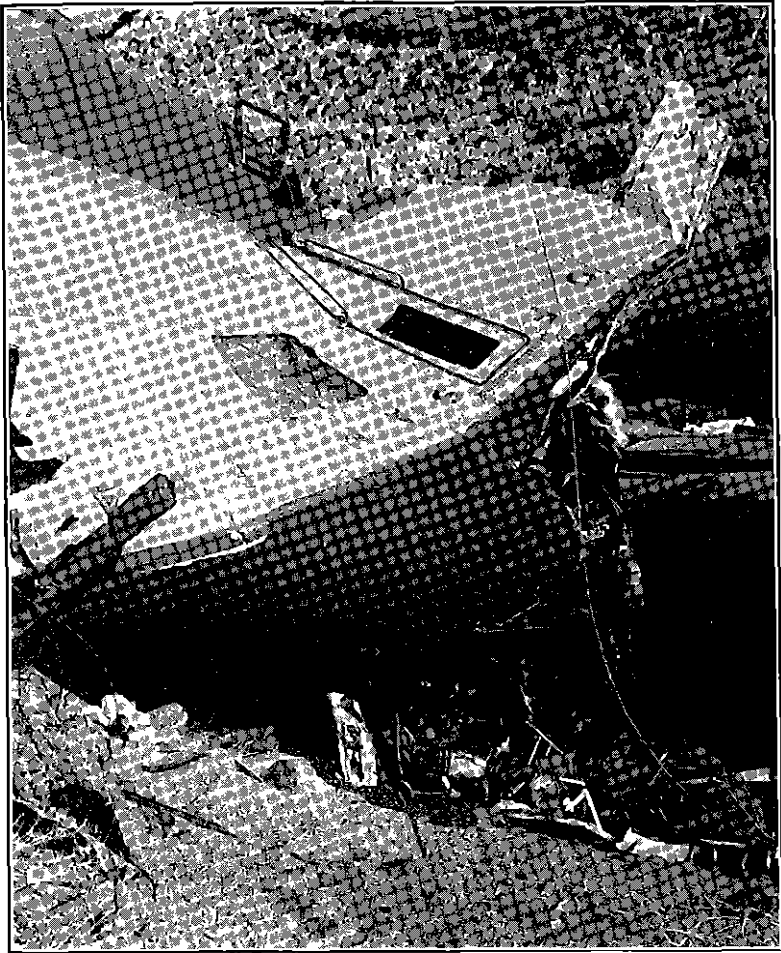
FIGURE 5—View of 'Presidio,' sixth unit showing damaged condition of roof

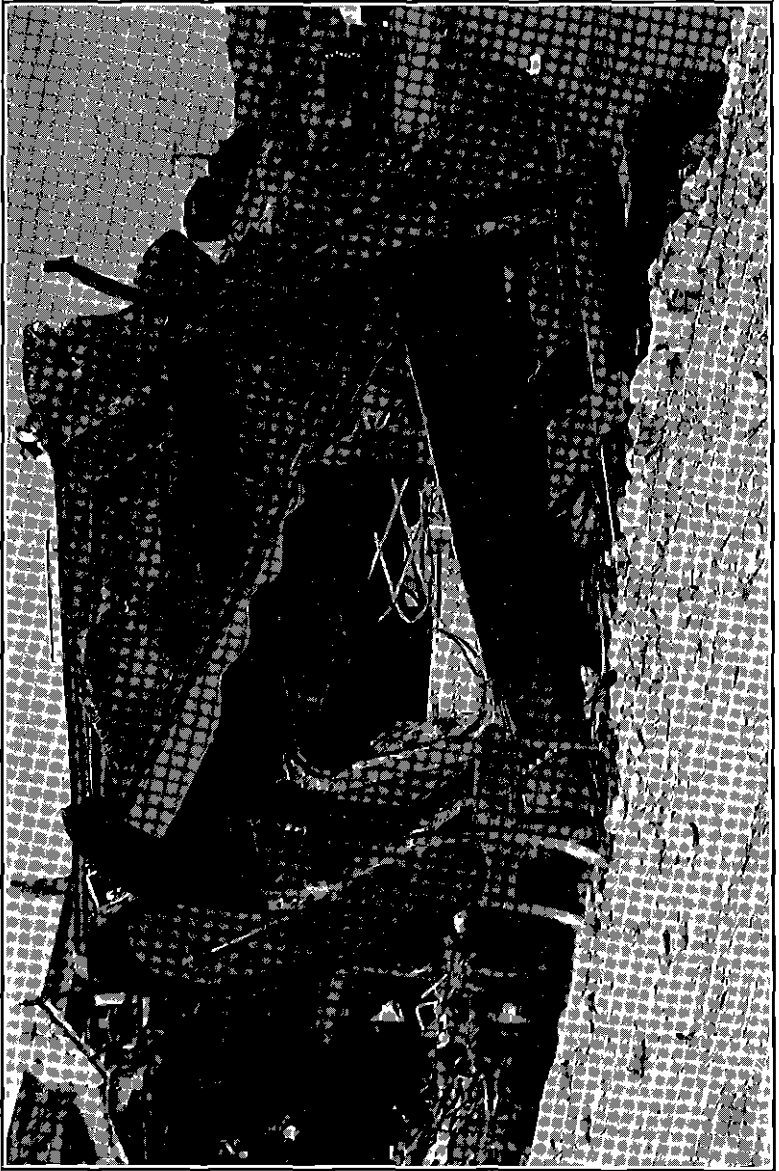
FIGURE 6—View of Mission Dolores, seventh unit, showing damaged condition of end frame

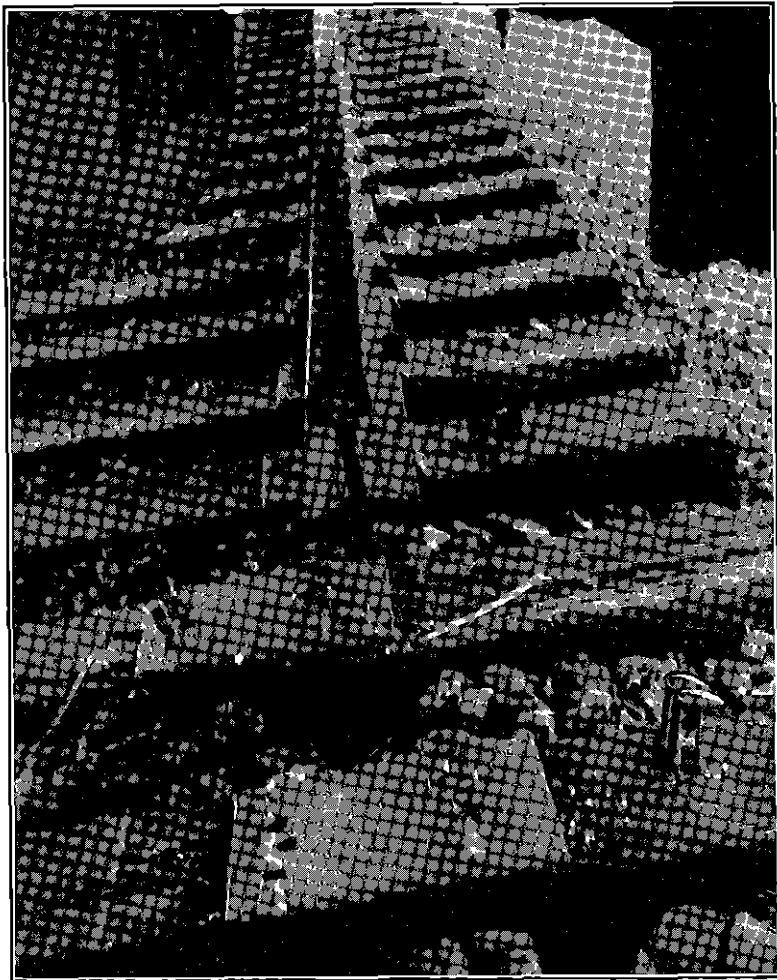
FIGURE 8—View of ties Nos 1 and 2, misaligned tie plate bond wires, nuts, washers, and fulcrum spikes in tie No 2

across the line of the track. Engineman Hecox identified this photograph as portraying conditions in the immediate vicinity of the disconnected rail joint exactly as he saw them.

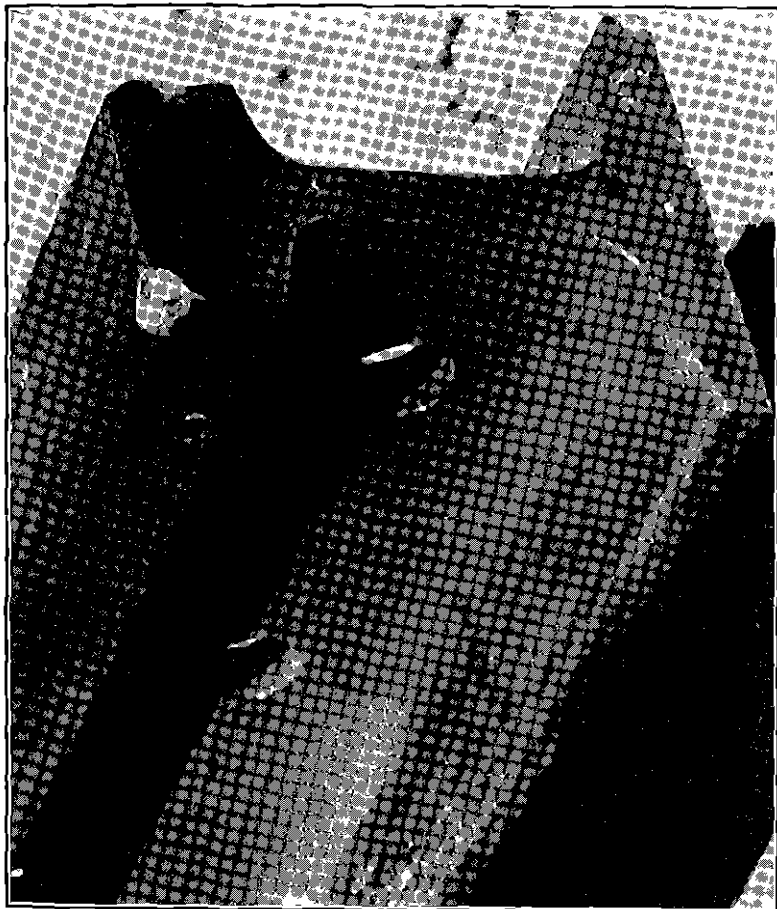
FIGURE 9 — View of receiving end of misaligned rail showing flange mark on outer corner of b III

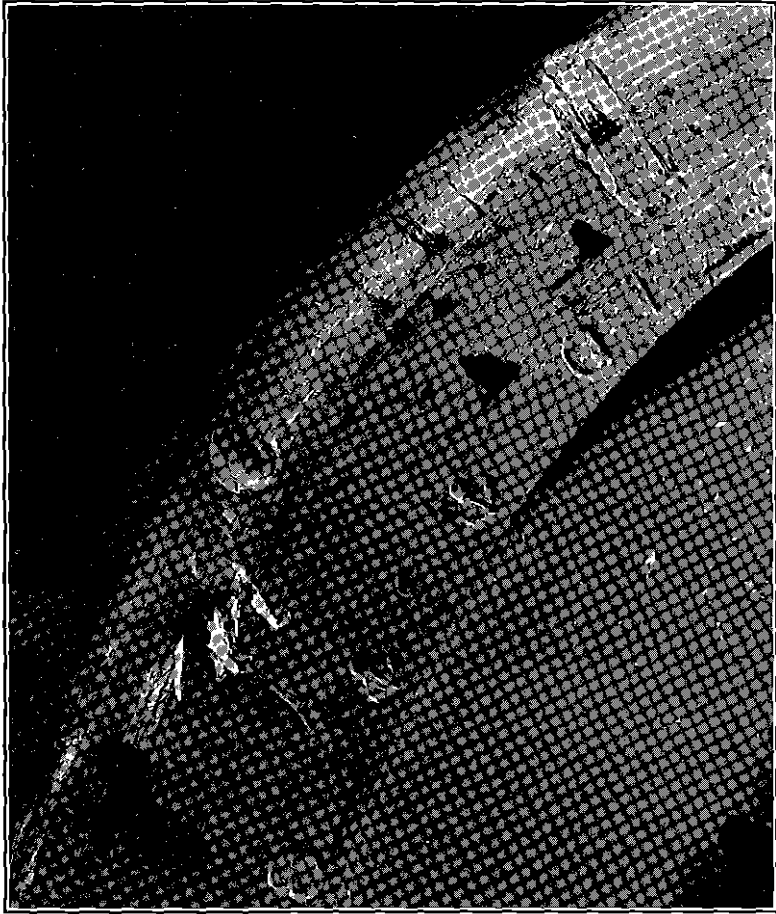
FIGURE 10 --View of back of flange of left No. 1 wheel of No. 1 power unit, showing mark caused by striking end of rail

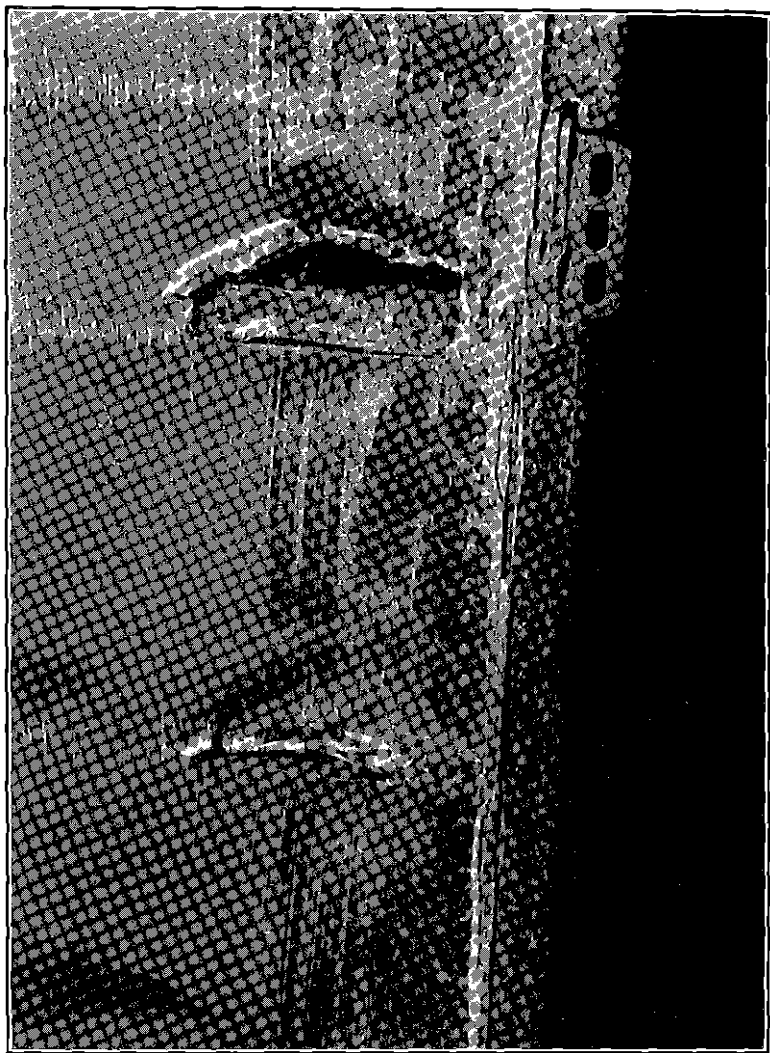
FIGURE 11 --View of fourth unit, showing results of sliding on lock ballast

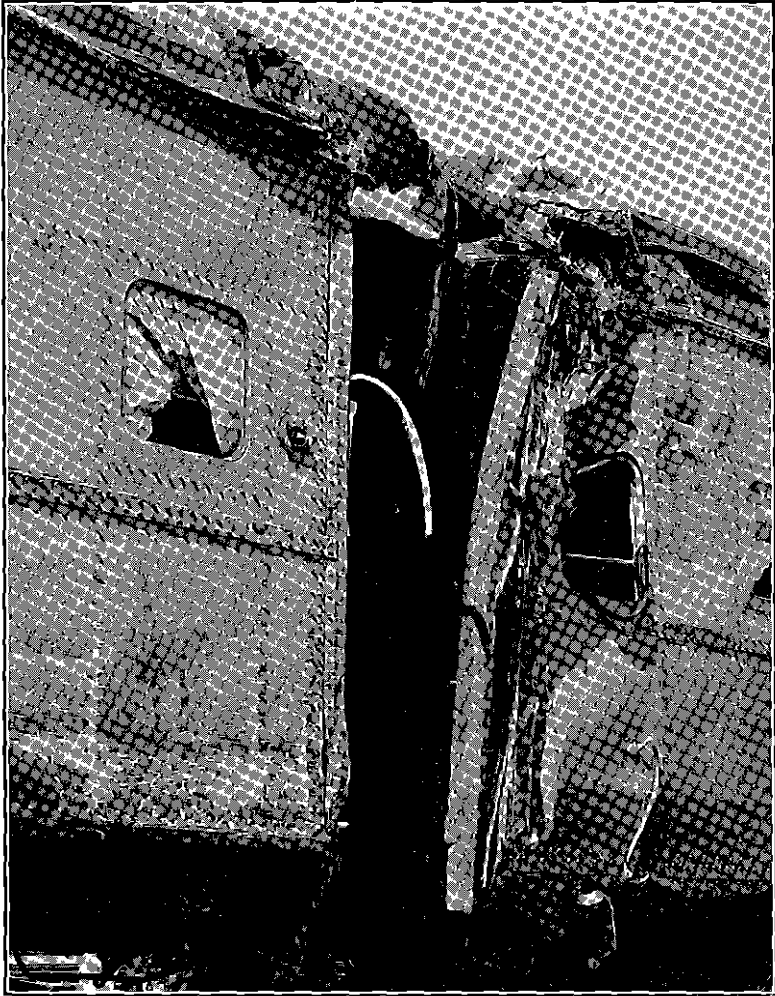
FIGURE 12—View of fourth and fifth units showing results of striking bridge tress
